Manhole Inspection Summary

Manhole # S43A2_017MH

Insp Date: **12/10/07 12:08 PM**

Location Address: **1001 E Patapsco Ave**

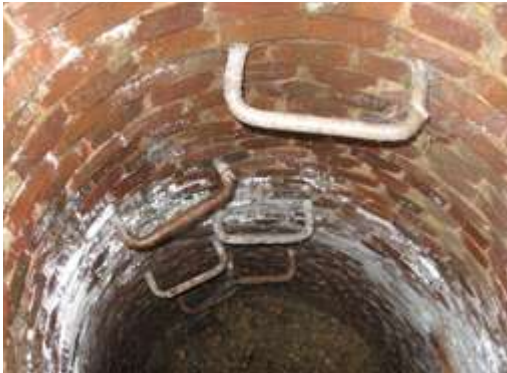
Steps Count: **6** Missing: **0** ☐ Corroded

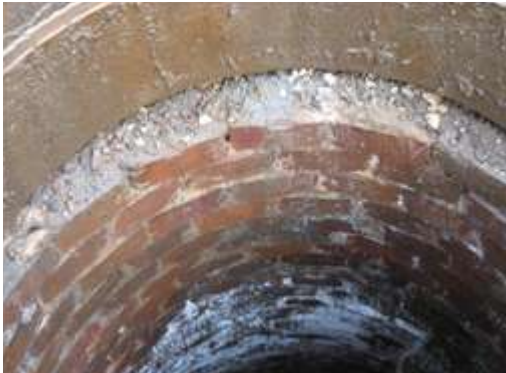
Defect 1

Frame Offset: **3** (in.) Condition: ☒ Sound ☐ Cracked ☐ Leaks

Frame offset

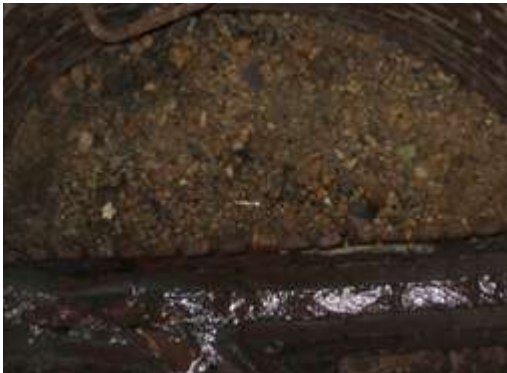
Defect 2

Debris

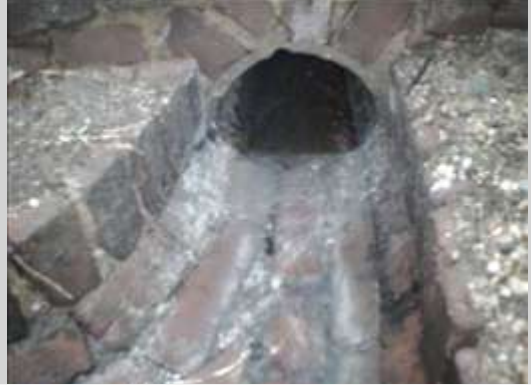
12 O'Clock Outflow

8 in. Circular Gravity Sewer
Pipe Out @ 12 O'Clock

Pipe Height: **9.6** (in.) Rod and Bar (Angled)
Pipe Material: **Clay** ☐ Pipe Lined
Invert Depth: **11.86** (ft.) Flow Characteristics: **Fast**
Deposits: ☒ None ☐ Mud ☐ Sludge ☐ Debris ☐ Grease
Silt Depth: (in.) Deposits Extent:
Infiltration: **None** Pipe Seal Cond: **Sound**

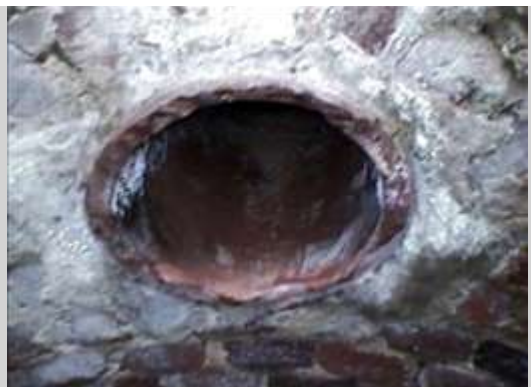
6 O'Clock Inflow

8 in. Circular Gravity Sewer
Pipe In @ 6 O'Clock

Drop In @ 6 O'Clock

Pipe Height: **9.6** (in.) Rod and Bar (Angled)
Pipe Material: **Clay** ☐ Pipe Lined
Invert Depth: **6.91** (ft.) Flow Characteristics: **Fast**
Deposits: ☒ None ☐ Mud ☐ Sludge ☐ Debris ☐ Grease
Silt Depth: (in.) Deposits Extent:
Infiltration: **None** Pipe Seal Cond: **Sound**

Drop: **Outside** Rod and Bar
Angled: **Yes** Reading: **10.58** (ft.)
Inv Depth: **11.58** (ft.)
Drop Condition: **Open**

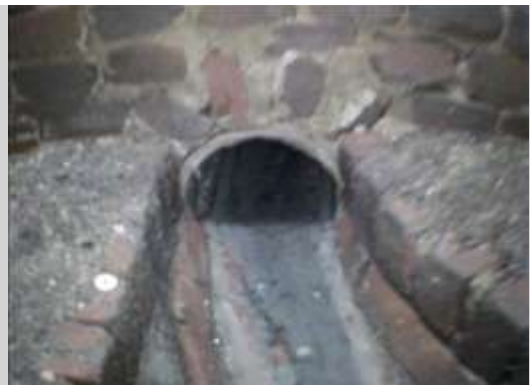
9 O'Clock Inflow

8 in. Circular Gravity Sewer

Pipe In @ 9 O'Clock

Infiltration: **None** Pipe Seal Cond: **Sound**
